# PLANNING JUSTIFICATION REPORT

**100 STOKES TRAIL**

**TOWN OF MILTON, ONTARIO**

*Brutto Consulting*

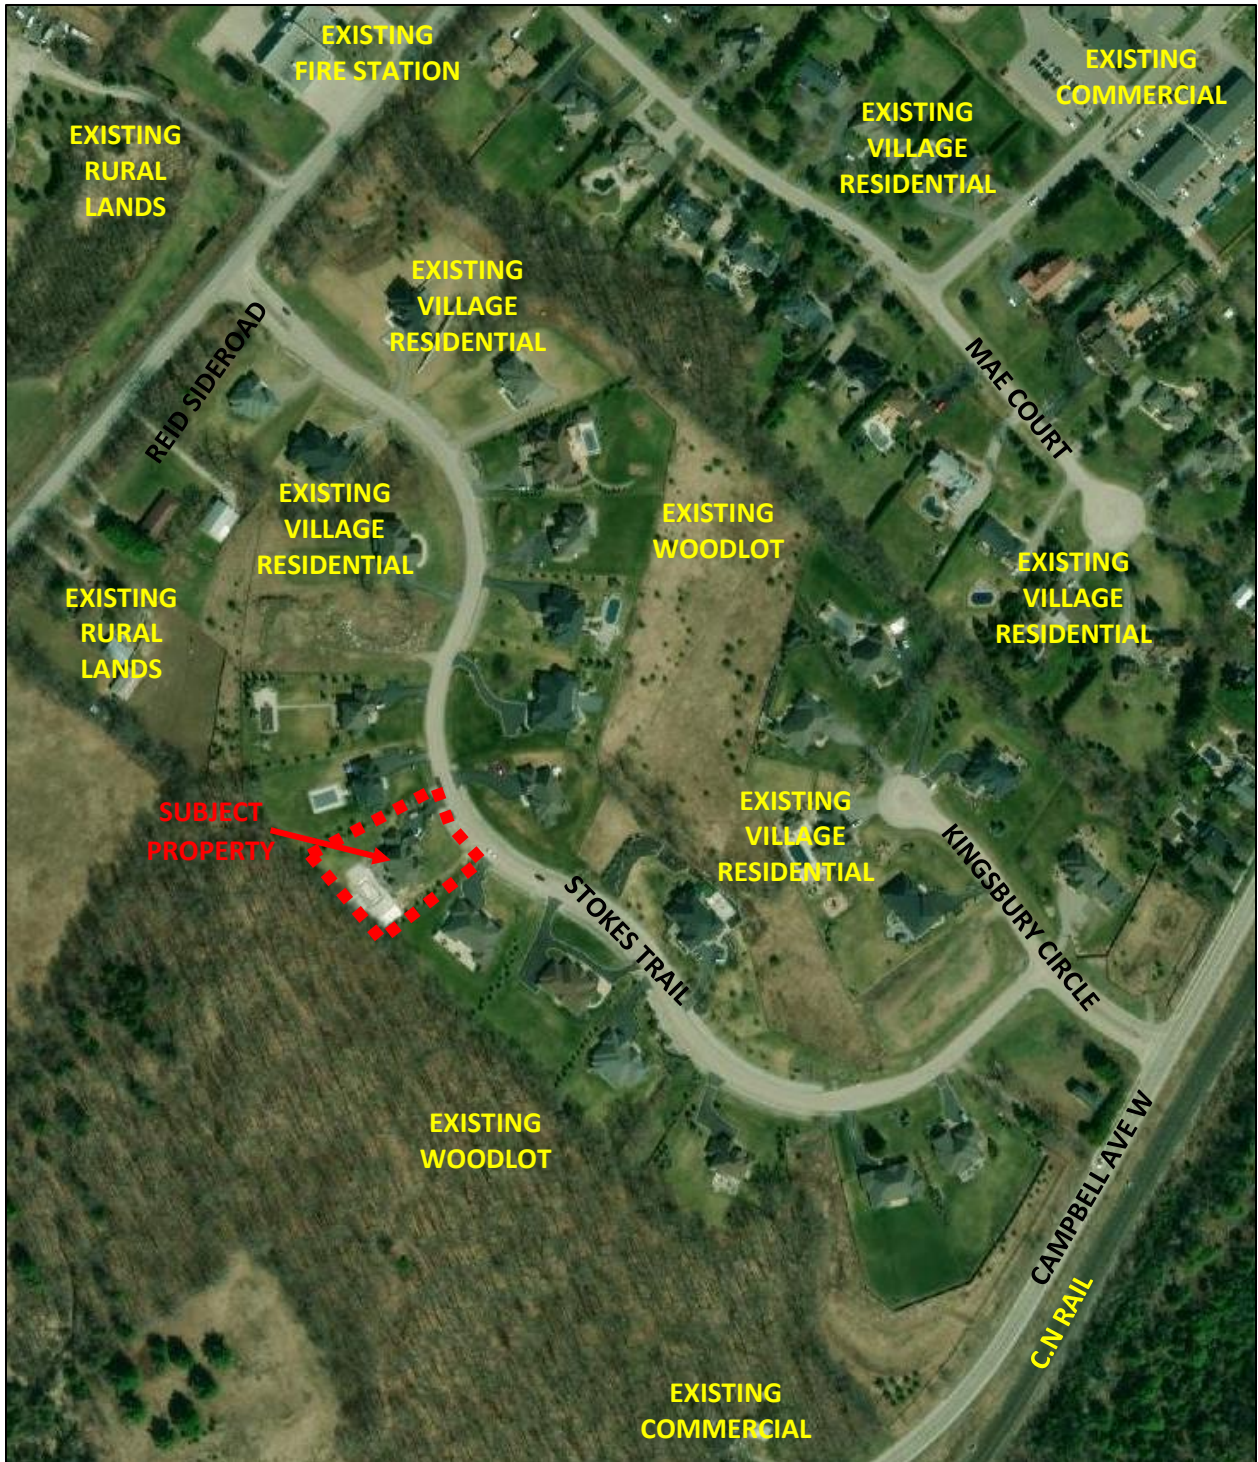
Figure 1: Site Context (Source: Milton Interactive Maps, 2022)

The land use context surrounding the Subject Lands is described as follows (*See Figure 1: Site Context*):

**North:** Single family detached dwellings of the Stokes Subdivision.

**East:** Single family detached dwellings of the Stokes Subdivision.

**South:** Single family detached dwellings of the Stokes Subdivision.

**West:** To the west of the subject property there is an existing forested feature.

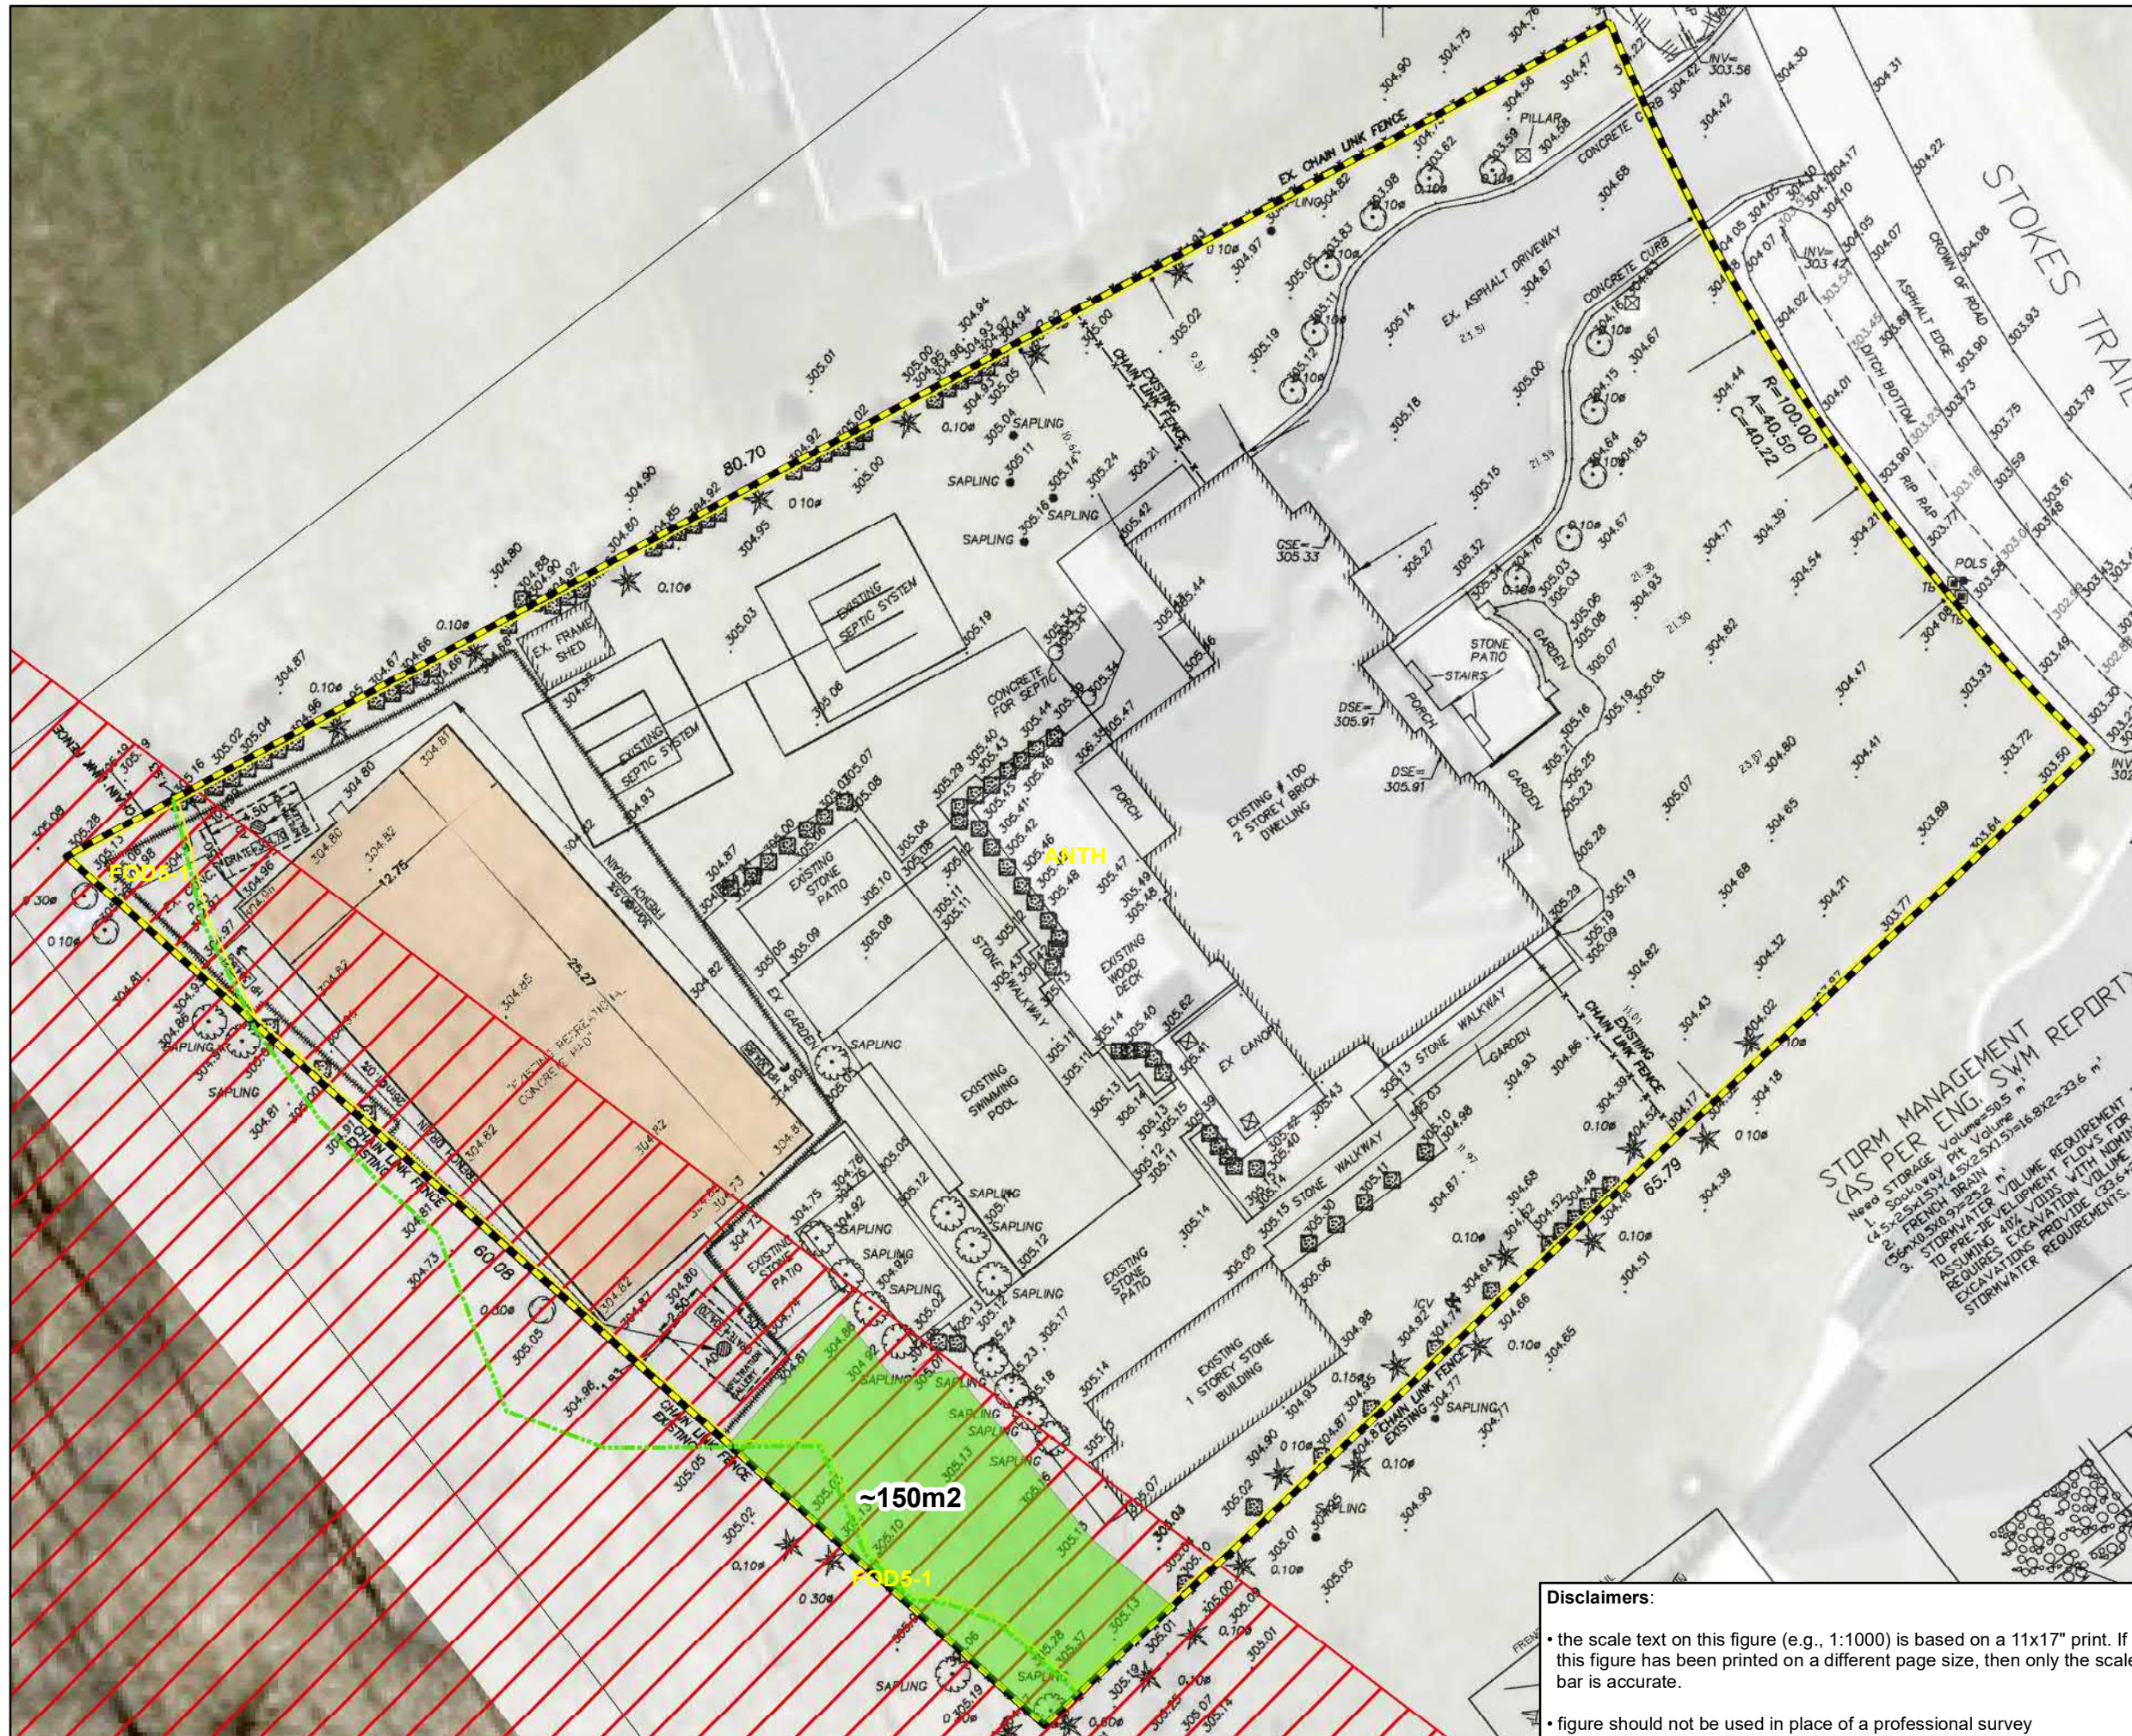
- Subject Property
- Dripline (RiverStone Jan 2022)
- Naturalization Area
- Tall Shrub/Low Tree Planting Location (Approximate - to be Field Fitted)
- Groundcover Planting Pod (Approximate - to be Field Fitted)

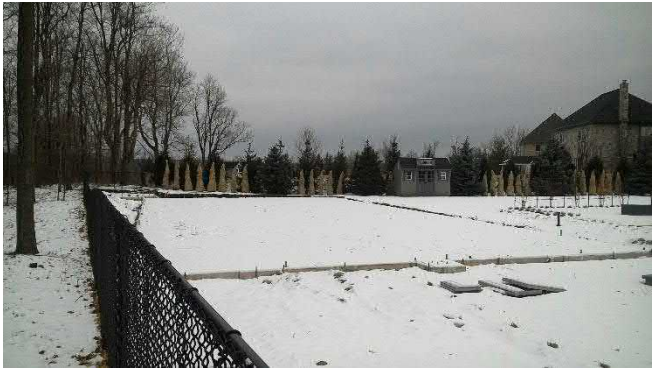
**Photo 1.** Facing northwest from rear lot line. Constructed sport pad in center of frame; dwelling on adjacent property to back right of frame.

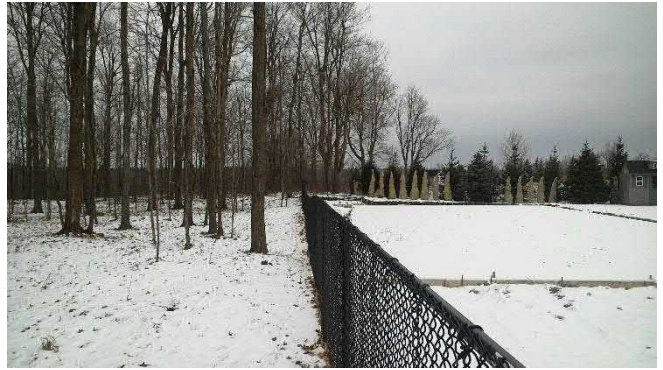
**Photo 2.** Facing west from rear lot line. Constructed sport pad on right, woodland feature on left.

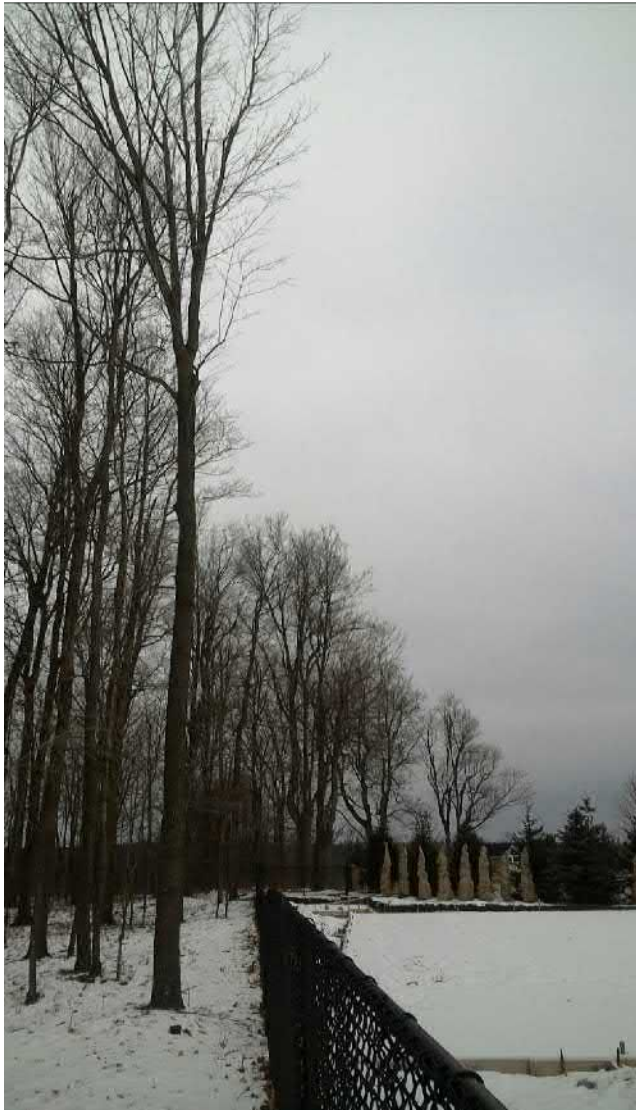
**Photo 7.** View of dripline facing west along rear lot line.

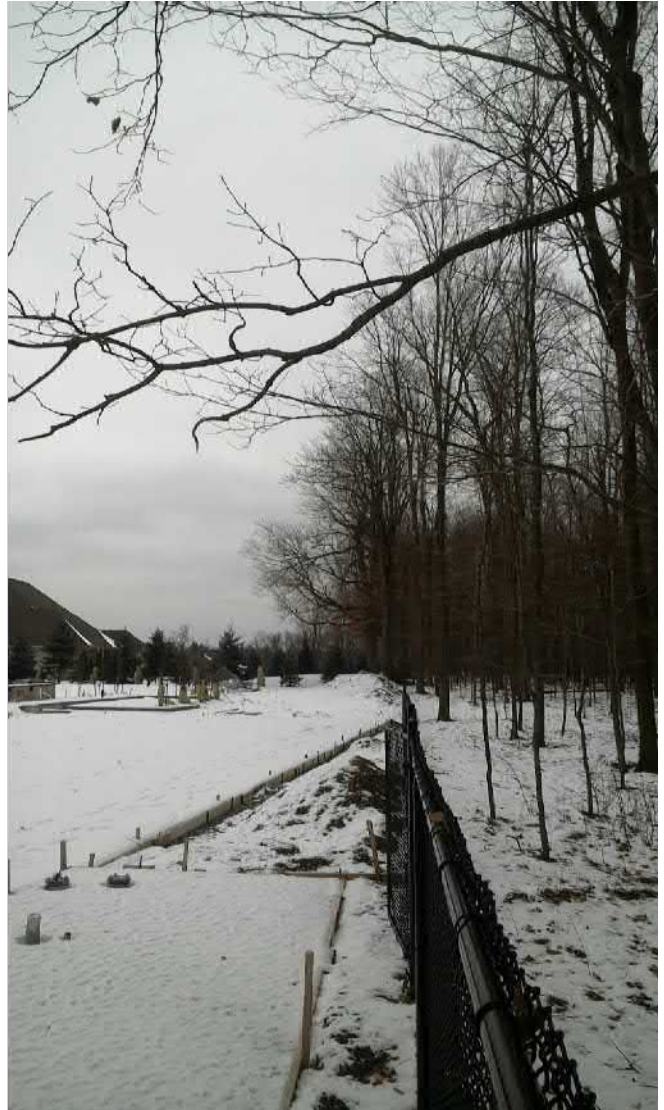
**Photo 8.** View of dripline facing east along rear lot line.

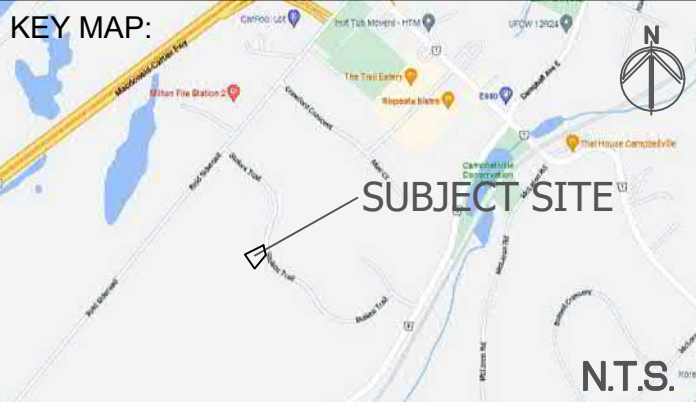
1:500		A100 21-970		01 ZONING RESUBMISSION		JAN 2024	
ORIGINAL DRAWING DATE:		ORIGINAL DRAWING DATE:					
VER-01		22/08/2022

- To permit a recreational concrete pad, lighting, and drainage infrastructure on a portion of the GB\*15 Zone; whereas the only permitted use in a GB\*15 Zone is naturalized vegetation.
- To permit a reduced Interior Side Yard for an Accessory Structure (Shed) of 1.07m; whereas the minimum required interior side yard setback is 3.0 m.
- To permit a reduced Rear Yard Setback between the Recreational Concrete Pad and the Rear Property Line of 0.48 m; whereas the minimum required rear yard setback is 6.0 m.
- To permit an increased total aggregate gross floor area for accessory buildings of 76.45 m<sup>2</sup>; whereas the maximum permitted is 66.6 m<sup>2</sup>.

PROPERTY AREA	3,528.16 m <sup>2</sup> (0.35 ha)
LOT FRONTAGE	40.50 m
FRONT YARD	21.30 m
SIDE YARD (E)	11.01 m
SIDE YARD (W)	9.51 m
REAR YARD	30.77 m
DWELLING HEIGHT	2—STOREYS

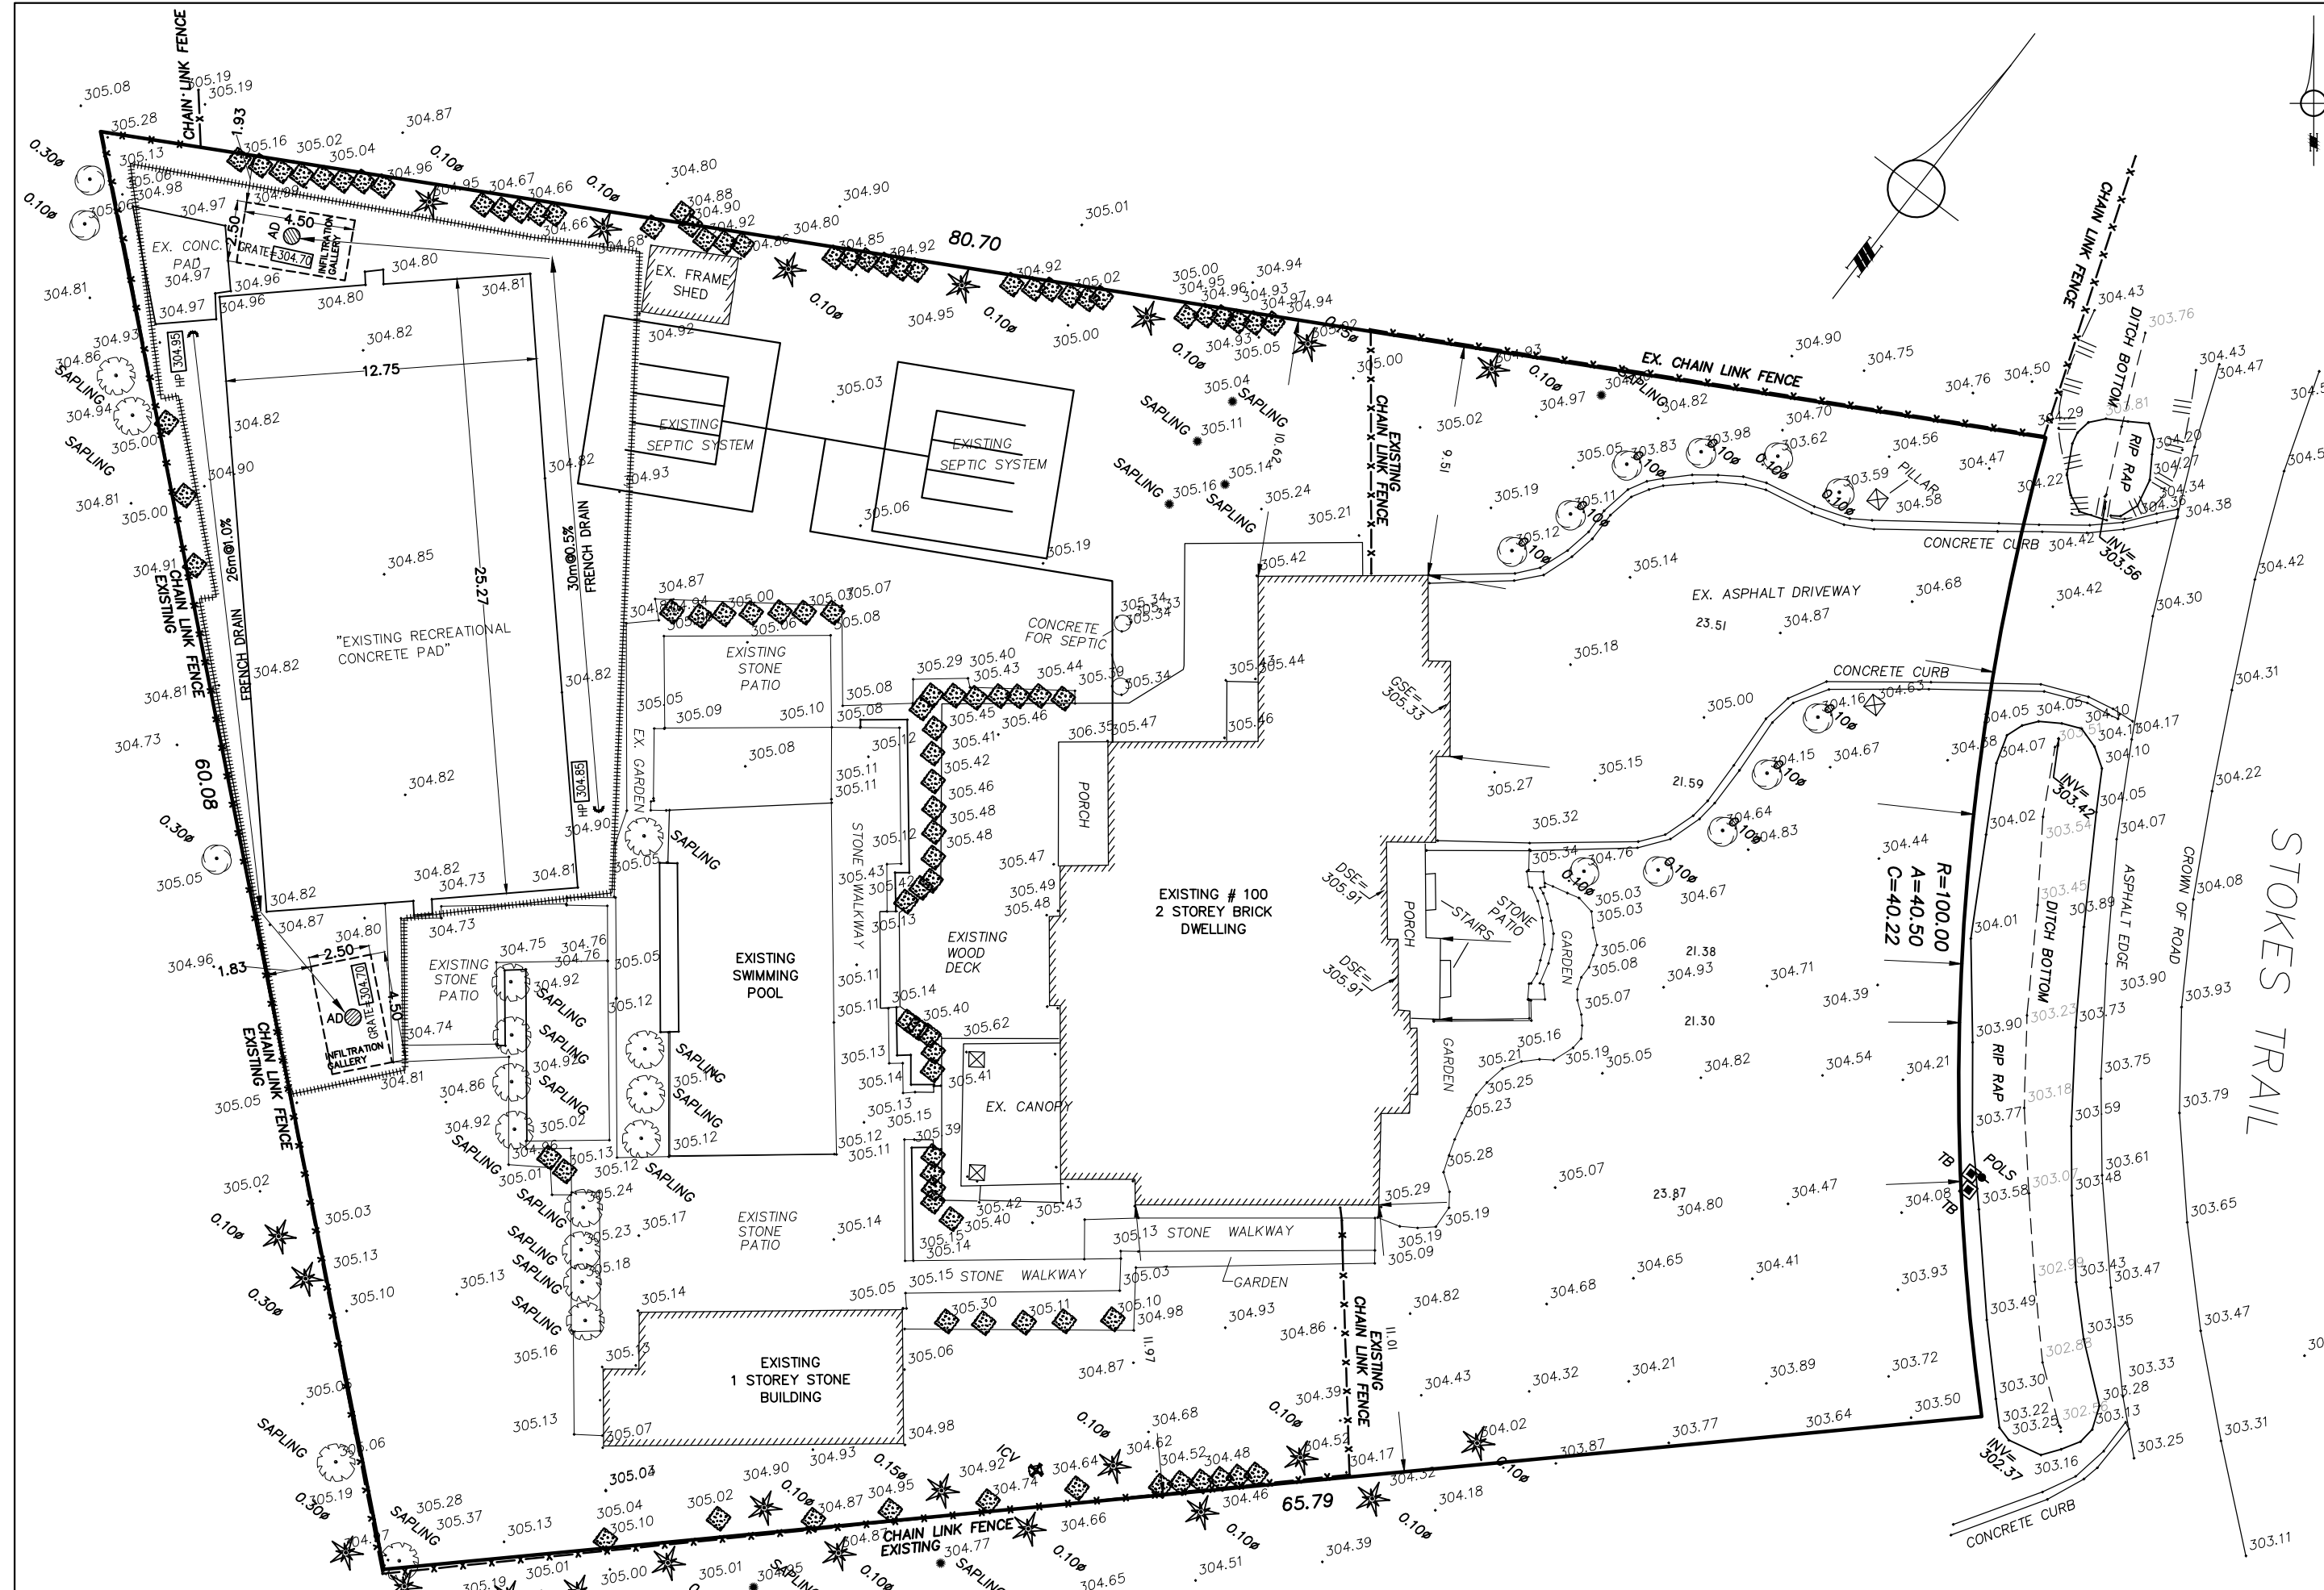
**STORM MANAGEMENT (AS PER ENG. SWM REPORT)**

Need STORAGE Volume=50.5 m<sup>3</sup>

1. Soakaway Pit Volume (4.5x2.5x1.5)+(4.5x2.5x1.5)=16.8x2=33.6 m<sup>3</sup>
2. FRENCH DRAIN (56mX0.5X0.9)=25.2 m<sup>3</sup>
3. STORMWATER VOLUME REQUIREMENT TO CONTROL POST-DEVELOPMENT TO PRE-DEVELOPMENT FLOWS FOR THE RECREATIONAL PAD = 20.2 m<sup>3</sup>. ASSUMING 40% VOIDS WITH NOMINAL 50mm DIAMETER STONE BACKFILL REQUIRES EXCAVATION VOLUME OF 20.2 / 0.4 = 50.5 m<sup>3</sup>. PROPOSED EXCAVATIONS PROVIDE (33.6+25.2=58.8 m<sup>3</sup>) AND SATISFY THE STORMWATER REQUIREMENTS.

The Grading Plan does not propose to modify the existing topographic conditions on site and does not propose the removal of any trees or existing vegetation. The grading design proposes to add two french drains and two infiltration galleries adjacent to the concrete sports pad in order to accommodate additional stormwater flow volumes from the pad's surface. The additional flow volumes generated by the concrete pad are considered minor and will not cause any negative impacts on the Subject Property or on adjacent properties. The proposed french drains and infiltration galleries will help retain stormwater on the property by redirecting it away from paved surfaces and allowing it to slowly infiltrate into the soil. The flow volumes generated by the concrete pad will be contained in-situ.
