# Phase I Environmental Site Assessment 1334 Fourth Line Part of Lot 7, Concession 4, Trafalgar Town of Milton, Ontario

Prepared for: Mattamy (Brownridge) Ltd. c/o Shad & Associates Inc. 83 Citation Drive Unit 9 Vaughan, Ontario L4K 2Z6

October 28, 2011

Pinchin File: 70791.001

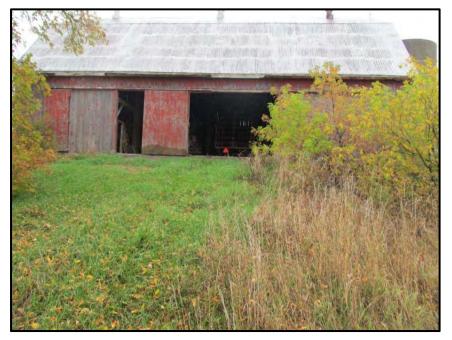
Photo 1 – View of Site Building A.

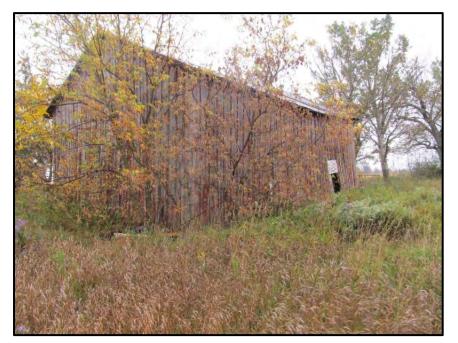
Photo 2 – View of Site Building B.

Given the year of construction of the Site Buildings (circa 1930s), there is a potential for paints containing lead to be present on Site, including Site Building interior surfaces. Pinchin did not conduct a survey of lead in painted surfaces as part of this Phase I ESA, and the Site Representative advised Pinchin that no surveys have been previously conducted at the Site. Pinchin observed that painted surfaces throughout Site Building B were in poor condition (i.e. peeling and flaking).

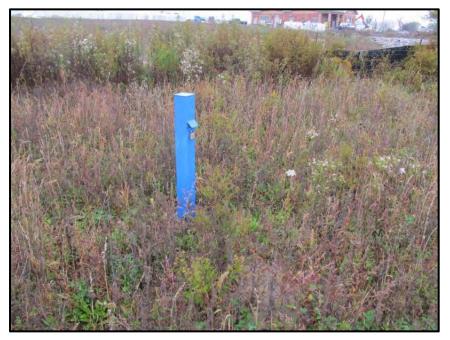
Photo 3 – View of monitoring well on northeast portion of Site.

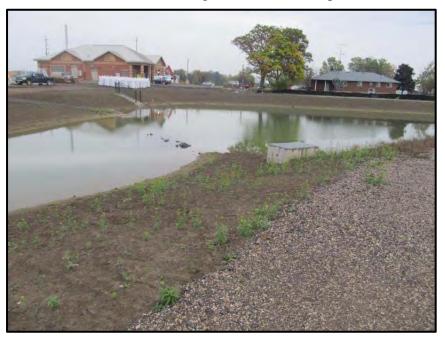
A drainage ditch was observed along the northeast Site boundary. A stormwater pond was observed in the northeast corner of the Site. Sixteen Mile Creek was located approximately 1.4 km southwest of the Site.

Photo 4 – Storm water pond within north corner of Site and adjacent properties to the north.

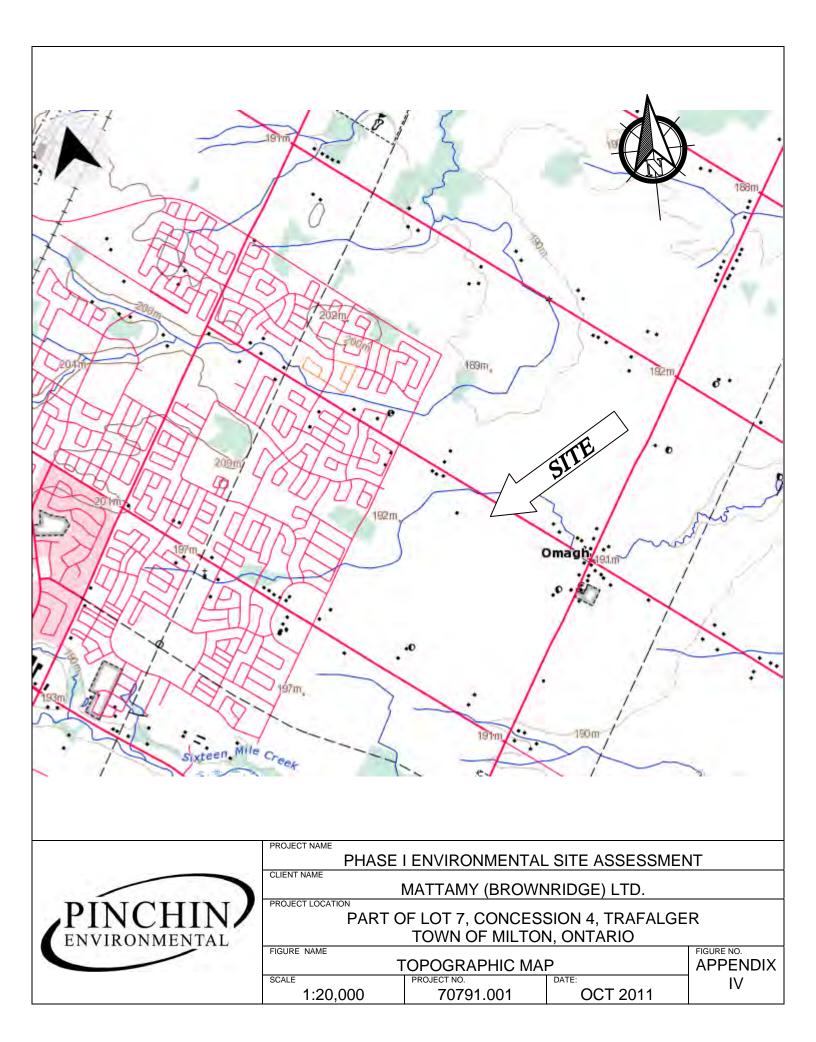
APPENDIX IV TOPOGRAPHIC MAP

Торіс	Findings
Topography of Site and Surrounding Area	A topographic map is presented in Appendix IV. Both the Site and the Phase I ESA study area generally slope down to the southeast.
Site Grade Relative to the Adjoining Properties	The Site was at a similar grade to the adjoining properties.
Subsurface Soils	Glaciolacustrine deposits: Massive to laminated silt and clay.
Bedrock Type	Red shale of the Queenston Formation.
Inferred Bedrock Depth	Greater than 8.2 mbgs based on information provided in the well records for the well located on the property immediately northeast of the Site (Section 4.3.5).
Inferred Groundwater Depth	Approximately 1.8 mbgs, based on information provided in well records.
Fill Material	None observed.
Inferred Groundwater Flow Direction	Southwest based on the nearest body of water and the topography of the Phase I ESA study area.
